Monitoring Data Record

Project Title: I-2511CB (I-85 Widening) COE Action ID: 200221534  
Stream Name: Town Creek (Site 5) DWQ Number: 040271  
City, County and other Location Information: Rowan County, I-85 Widening (-TI-PINC Sta. 20+35)  
Date Construction Completed: Water turned on 12/6/06, Stream reforestation completed 12/13/06  
Monitoring Year: ( 2 ) of 5  
Ecoregion: \_\_\_\_\_ 8 digit HUC unit 03040103  
USGS Quad Name and Coordinates: \_\_\_\_\_

Section 1. PHOTO REFERENCE SITES

# Town Creek

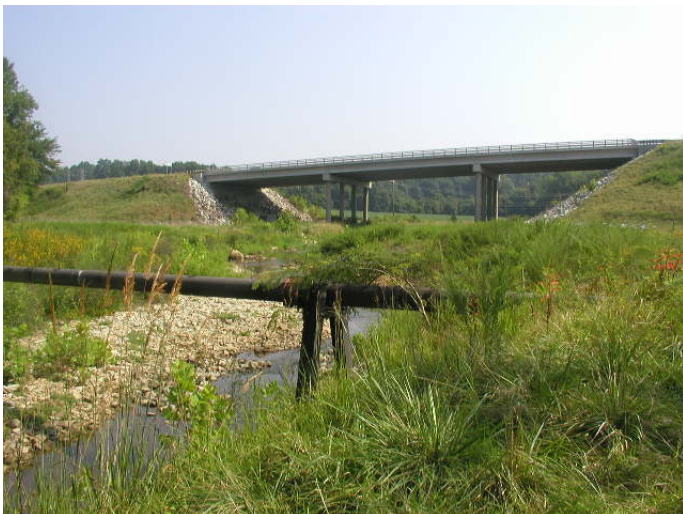
(Overview looking downstream of buffer area)

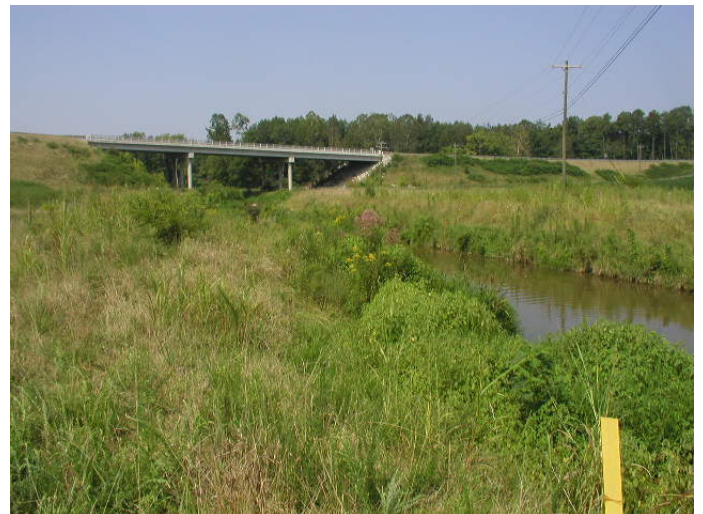
(Overview looking upstream of buffer area)
